NATURAL AND HUMAN-INDUCED SUBSIDENCE DUE TO GYPSUM DISSOLUTION: A CASE STUDY FROM INANDIK, CENTRAL ANATOLIA, TURKEY

Ergin Gökkaya^{1,C} and Esra Tunçel²

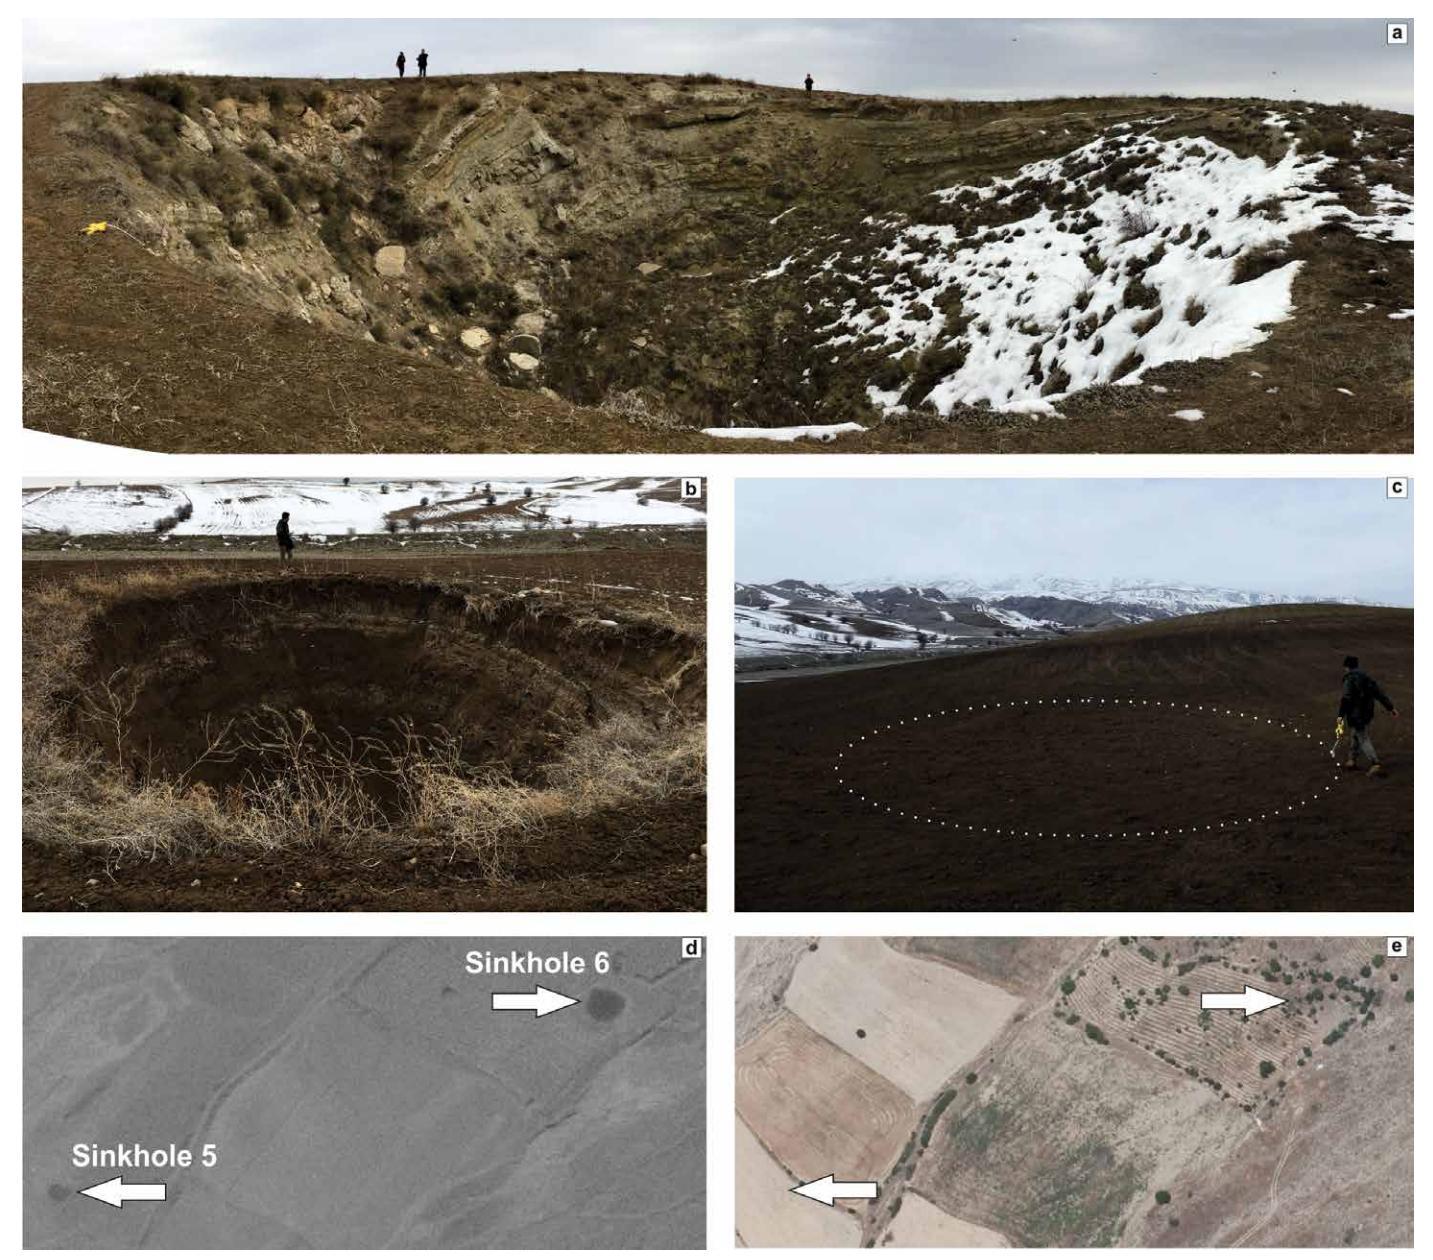
Sinkhole 2 (Fig. 2a) is the largest with a diameter of 44 m and depth of 22.5 m at an altitude of 877 m a.s.l. It is the only bedrock collapse sinkhole and was formed before 1953. Blocks were observed in its bottom and many fractures are visible around the sinkhole, indicating that it has enlarged due to mass wasting. This sinkhole in particular shows that large cavities exist under the terrace.

The most recent sinkhole is number 8 (Fig. 2b), formed in 2012. It is 13 m in diameter and somewhat enlarged since traces of erosion are visible at its margins, and is 10 m deep. The depth of the sinkhole is 5 m greater than the thickness of the alluvial deposit. It is classified as a cover-collapse sinkhole.

The other sinkholes can only be observed in some of the aerial photographs. They have now disappeared because farmers have filled them, canceling the surface features (Fig. 2c, d, e). These buried sinkholes can also be defined as

Figure 2. (a) Panoromic view of Sinkhole 2, the deepest and largest sinkhole in study area. Note separated blocks on the sides. (b) Sinkhole 8, most recent sinkhole in study area. (c) Sinkhole 4, buried by farmers. Soil containing small white pebbles brought from elsewhere mark the sinkhole within the boundary indicated. (d) Historical aerial photograph of sinkholes 5 and 6. (e) Recent view of buried sinkholes 5 and 6.

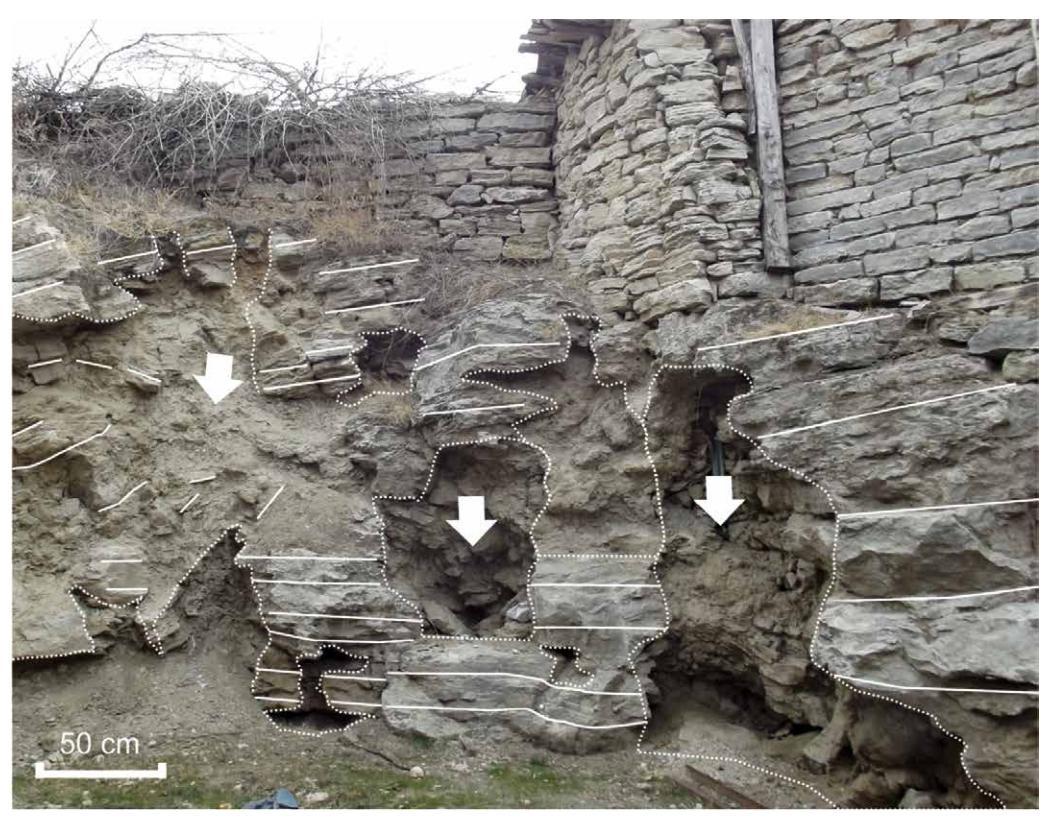
Figure 3. Paleo-subsidence structures in gypsum bedrock. Cavities are filled with karstic residue and gypsum blocks. (Photograph taken on eastern slope of village).

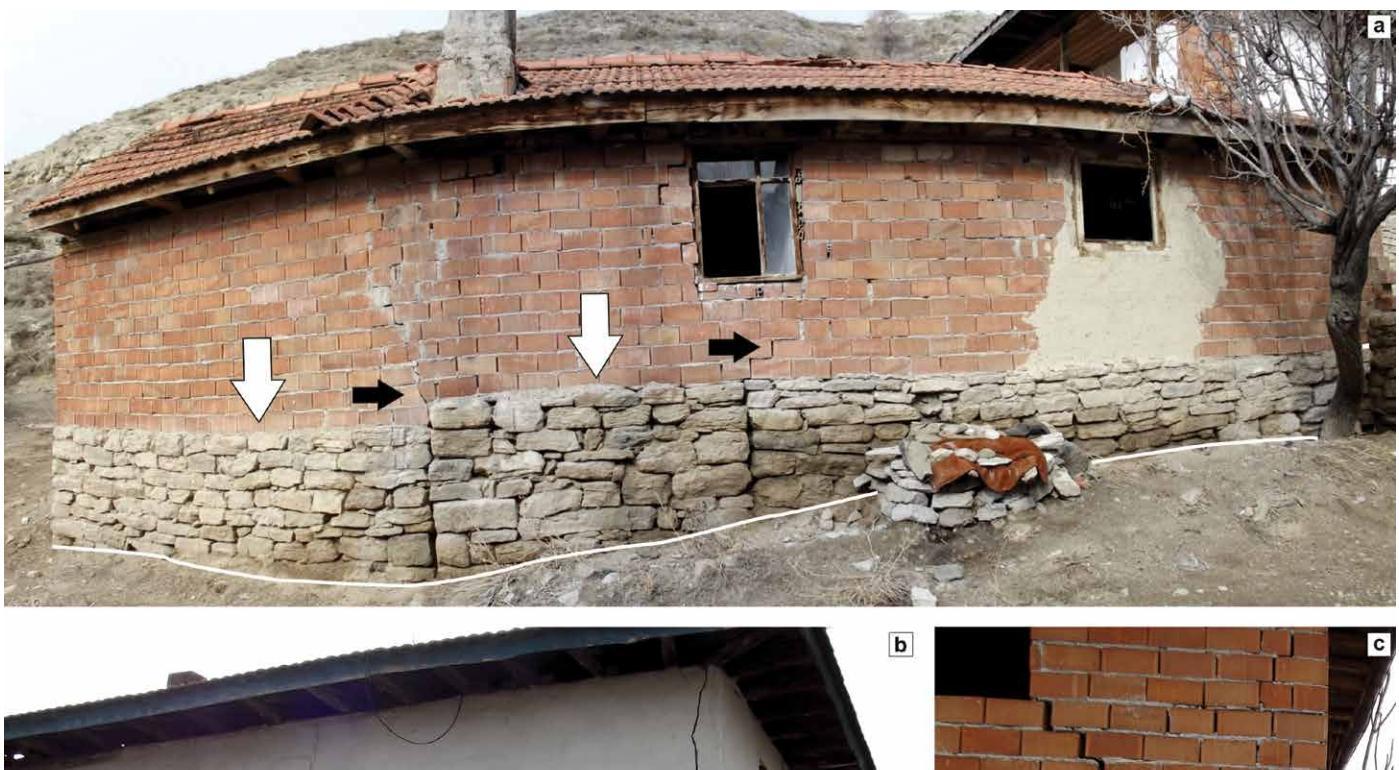
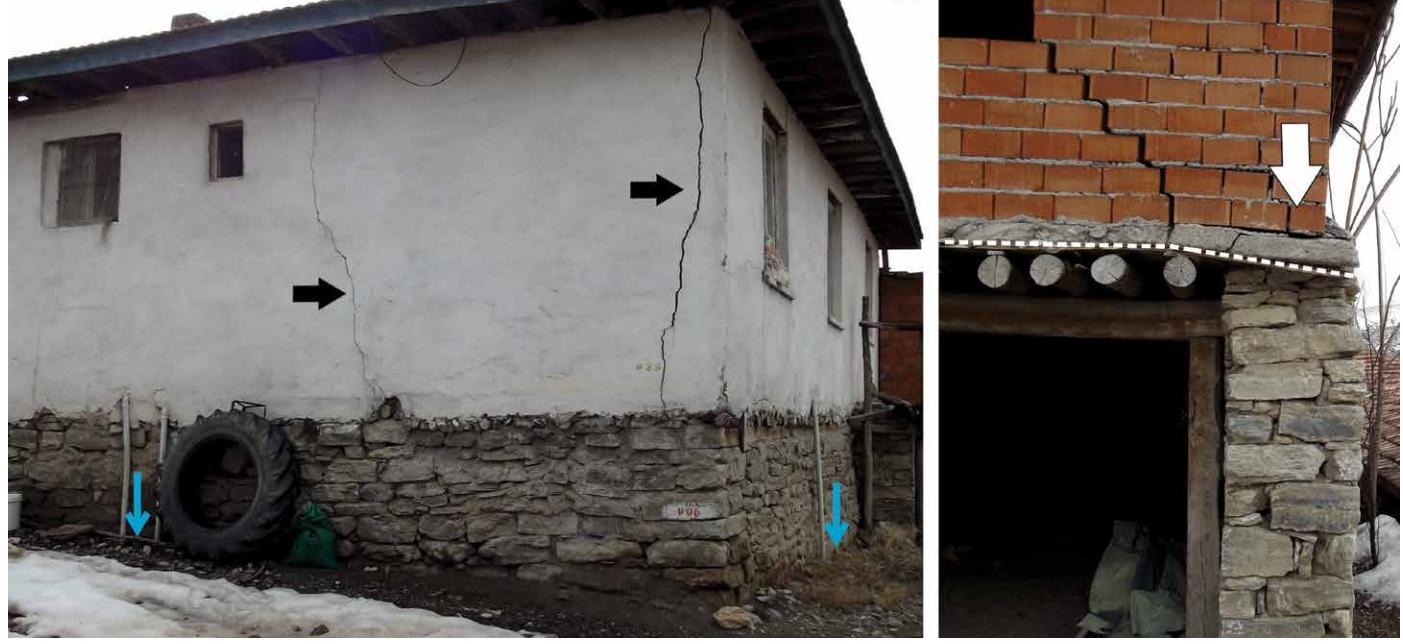
which show open fractures and tilted, cracked walls (Fig. 4). Moreover, some of the buildings are very old; therefore they are severely affected by even the slightest subsidence. Several have been demolished because the damage was beyond repair.

Figure 4. (a) Displacement of house wall showing bulging and cracking caused by subsidence, and broken windows due to distortion. (b) Cracks on wall and pipes draining wastewater directly into ground. (c) Open joint in wall of building. (Photographs taken on February 26, 2017).

It is hoped that the results of this study will contribute to increasing the awareness among decision-makers who need to consider the karst system of the area they are responsible for in order to take preventative measures. To reduce or prevent hazards related to subsidence in a settlement which overlies gypsum, such as Inandık, extra water input to the subsurface should be minimized (Parise, 2015) and flexible pipes with a telescopic joint should be used to alleviate cracks and breakage.

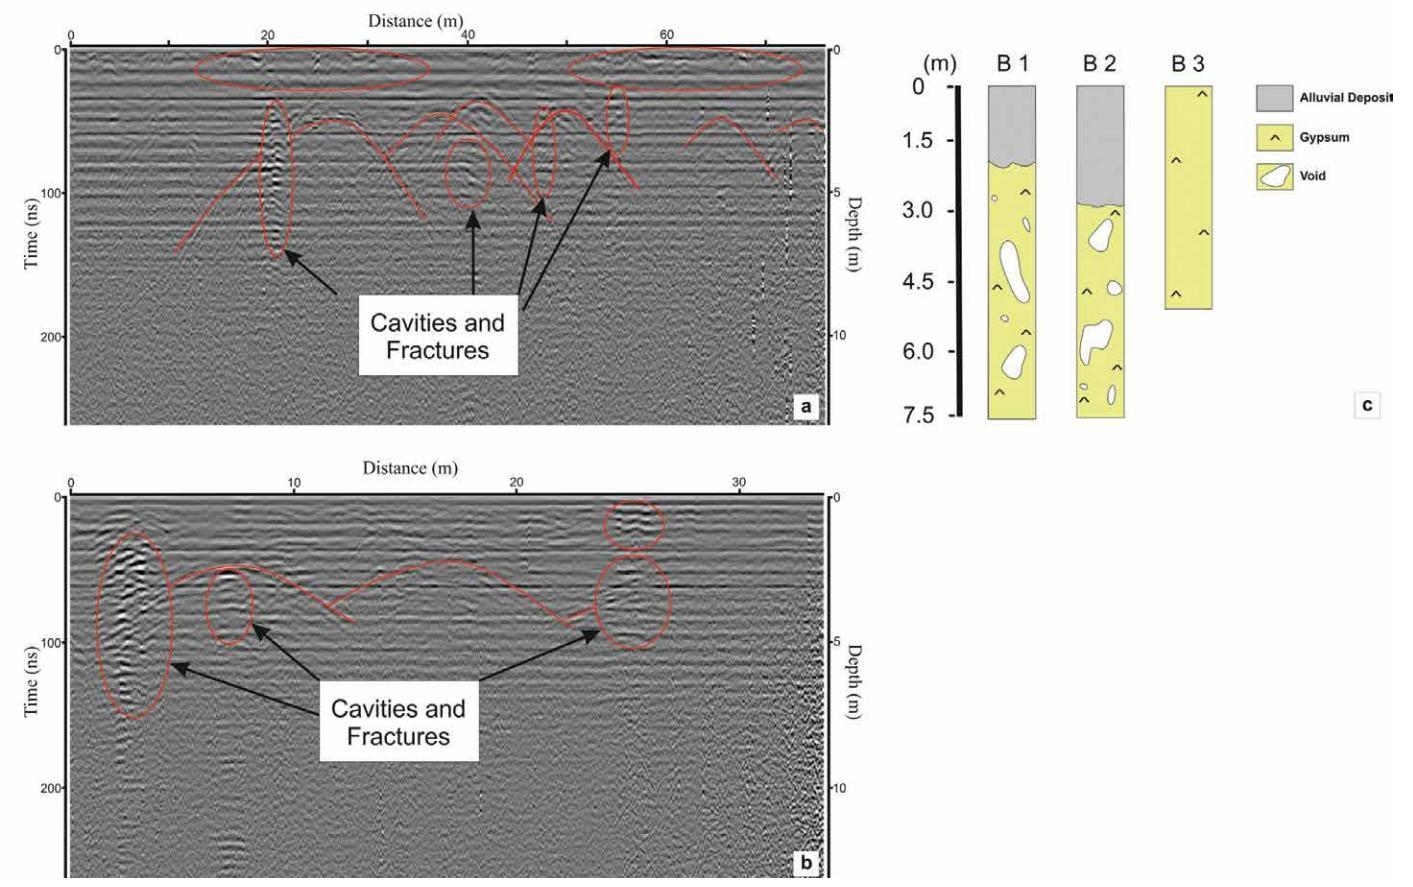
Five GPR profiles with a total length of 565 m (Fig. 5) were obtained from the settlement area (Özçelik et al., 2016). Profile 1 (Fig. 6a) mostly concentrates on the in-house and sewage water pipelines and shows shallow and relatively deep anomalies. Shallow anomalies between 20 and 32 m, and between 55 and 70 m are observed at a depth of 1 – 10 m. These reflections with different dips in this profile are likely related to sagging structures. Relatively deep anomalies are also observed 20 m and 40 m from the beginning

of the profile at a depth of 50-100 m. Profile 5 (Fig. 6b) focuses on the area northwest of the village. It shows anomalies located from the beginning of the profile at 10, 20, and 30 m and having a depth from 10 to 100 m. Shallow anomalies at 10 m and 25 m along the profile show a sagging structure. These anomalies seen on profiles 1 and 5 probably correspond to fractures, cavities, and sagging structures near the surface in the gypsum bedrock (Fig. 6a, b). Profile 1, located below the most damaged area, shows several anomalies more than profile 5, and both the anomalies and damaged buildings decrease towards the end of profile 5. These observations are compatible with the spatial distribution of the damage. Although the effect of subsidence was observed in structures near the other three profiles (Fig. 5), anomalies were not de-

Boreholes 1 and 2 were drilled in the valley bottom of Inandık village (Fig. 5). Both boreholes show dissolution cavities in the gypsum (Fig. 6c). According to this data, the thickness of the alluvium is 1.5-3 m. Borehole 3 was drilled on the bedrock northwest of the village. No void was detected in its log 3 (Özçelik et al., 2016).

Figure 6. GPR profiles of (a) profile 1, and (b) profile 5. (c) Log of boreholes drilled in Inandık village (modified from Özçelik et al. 2016).

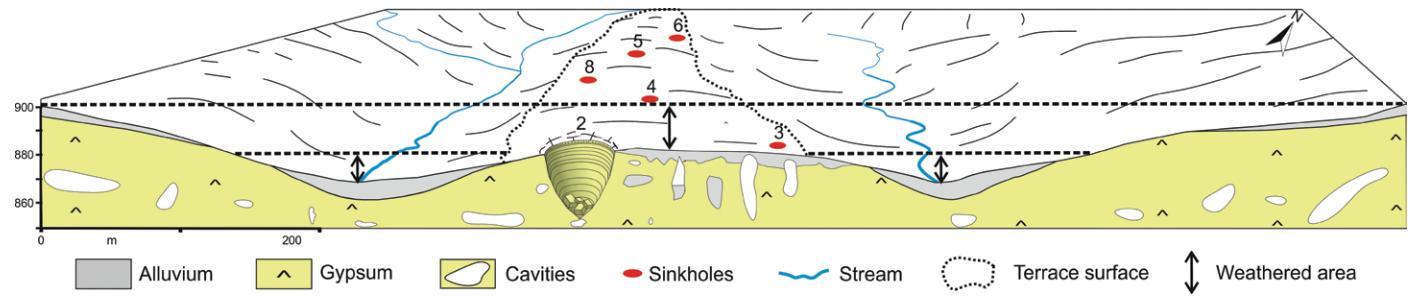
There was no sinkhole formation on the adjacent heights of the terrace (Fig. 7) because they have a relatively thick cavity roof. In the valley bottom, the alluvial cover is thicker and the hydraulic gradient is lower; therefore, only sinkholes 1 m wide or smaller were formed there.

Figure 7. 3D Geomorphological scheme (A-B) of Inandık stream showing flow level differences and sinkholes (See Figure 1c).

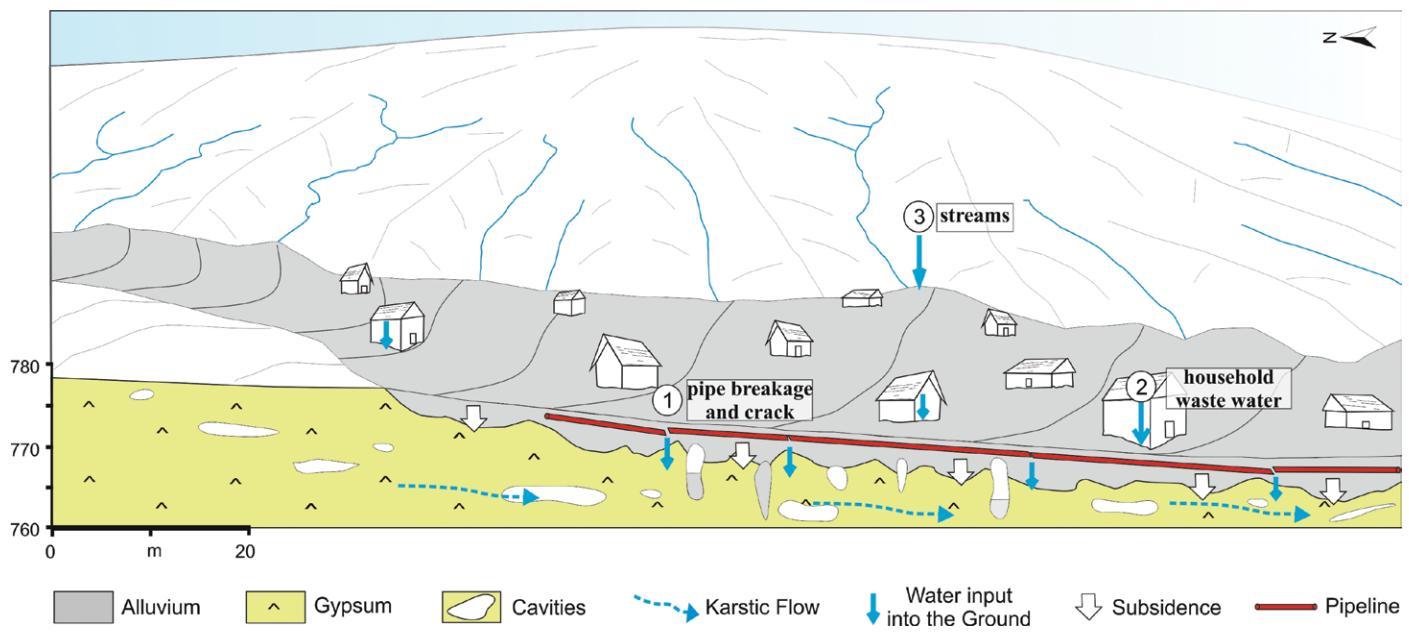
In-house service and sewer pipes are more likely to cause subsidence (Fleury, 2009; Parise, 2015) and pipeline breakage gives rise to damage in karst areas (Jassim et al., 1997; Gutiérrez and Cooper, 2002; Cooper et al., 2011; Cooper and Gutiérrez, 2013; Parise et al., 2015). In Inandık, ground subsidence must have caused the abnormally frequent breaking of pipes, which caused extra water input into the ground and triggered progressive subsidence of the land, creating a vicious circle. Moreover, some household waste water flows directly into the ground, which causes localized subsidence. All these processes give rise to dissolution and the formation of new cavities (Fig. 8).

Figure 8. Cross-section of pipeline (Fig. 5) and 3D geomorphological scheme of Inandık village depicting effect of subsidence.
