Challenges Encountered in Column Tests Under Eccentric Axial Load and Proposed Solutions

Ahmet Özbayrak

Erciyes University, Engineering Faculty, Department of Civil Engineering, Kayseri, Türkiye

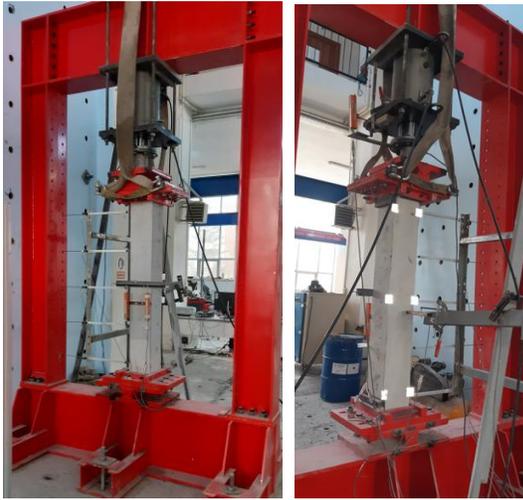
Figure 3: Taking measurements from the experimental setup

After the reinforced concrete columns were placed in the steel loading setup, displacement readings were taken with a total station between load controlled increments of 30 kN. During the experiments, 63 mm eccentric axial pressure loading was applied to the columns. For horizontal displacement readings, 5 potentiometric rulers were also used along the column height. Two LVDTs were used to read the shortening and elongation on the compression and tension faces, and one LVDT was used to control the deflections outside the bending plane. Finally, one LVDT was installed to measure the shortening of the column length (Figure 3).

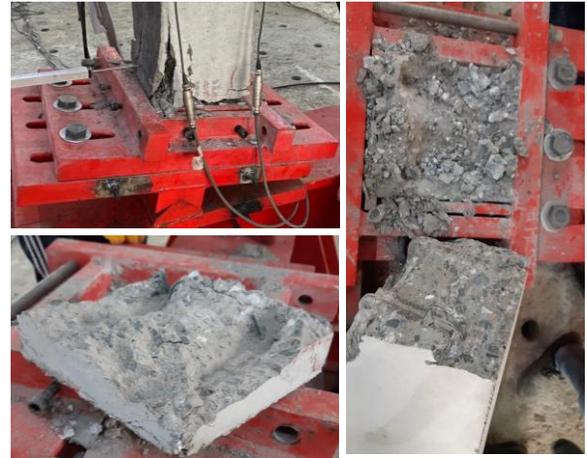
Figure 4. End of Test1

The upper and lower support plates, where the ends of the reinforced concrete column are connected, have rotational freedom. This allows the column body to bend (in a C-shape) due to eccentric axial loading, resulting in the expected form of failure. In the first test, the column fractured from the lower support region. The fractured part consists of plain concrete where the longitudinal reinforcement mitred, and where only concrete cover was left at the column end zones. As the axial load increased during the experiment, the concrete on the compression side of the column was crushed in the support regions. Subsequently, due to the moment effect and the absence of longitudinal reinforcements at the column ends, the

concrete cover in the end zone ruptured, leading to the end of the experiment (Figure 4).

After the investigation, it was concluded that the problem could potentially be resolved by cutting the average 25 mm thick concrete cover that had detached from the bottom column end. However, due to the initial lack of equipment for cutting, alternative solutions were explored. As a second approach, experiments were conducted by placing the column freely between the support plates in the test setup, without compressing the column ends. This approach aimed to prevent stress concentrations at the column ends by allowing the column to rotate on the plate surfaces, in addition to the rotational freedom provided by the support plates (Figure 5).

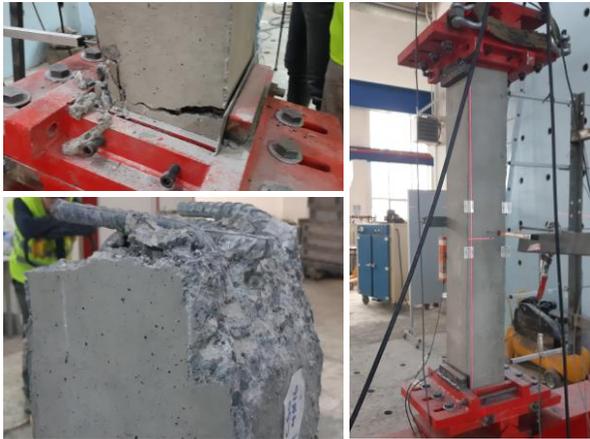
Figure 6. End of Test3

The issue of longitudinally reinforcing bars being mitred at the column end and concrete cover being placed perpendicular to the column cross-section revealed a production planning error. To address this, a third solution was implemented: the slot depth in the support plates where the column is placed was increased to 100 mm in the bending direction. This modification was intended to allow the tensile effect resulting

from the bending moment to be effectively resisted by the longitudinal reinforcements situated at levels higher than the lower end. Similar to the previous experiment, the column end was left free on the support plates without compression (Figure 6).

The increase in the slot depth in the support plates of the experimental setup has shifted the point of failure slightly higher. However, it was still unable to prevent the rupture of the concrete cover at the bottom end of the column. As a fourth solution, it was decided to confine the column within the slot using plates in a direction perpendicular to the bending plane, with a height of 100 mm. Despite the decrease in column slenderness due to the confinement of the column ends within a 100 mm deep slot instead of the previous 50 mm, it was assumed that this arrangement would allow for more effective performance of the longitudinal reinforcements along the column length (Figure 7).

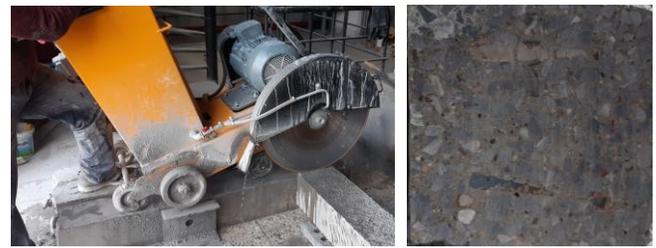
Figure 8. Concrete cutting

Finally, the only remaining option was to proceed with the initial plan of cutting the concrete cover at the column ends. For this purpose, the process of purchasing and procuring the necessary machinery has begun. After obtaining the machine, the columns were cut by 25 mm from both ends, reducing the column length to 1450 mm (Figure 8). This allowed the

longitudinal reinforcements to extend up to the top and bottom cross-sectional faces of the column.

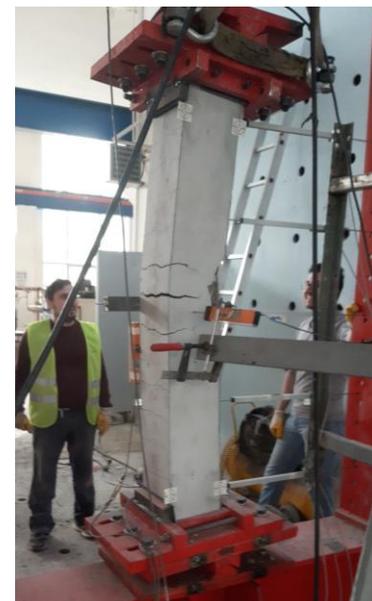
Figure 9. End of Test5

As a result of both the improvements made in the steel plates on which the column ends were supported and the cutting of the reinforced concrete column ends, the experiment was successful. Although the column slenderness decreased slightly, the fracture occurred in the center of the column due to bending. The column reached its full load carrying capacity and more accurate data were obtained for the evaluations to be made (Figure 9).

Longitudinal reinforcements that will meet the bending moment effect occurring in the end regions of the column should extend to these regions without mitring. Additionally, the slot depth in the bottom and top loading plates, where the column is supported in the experimental setup, should be increased to limit the bending effect in the end regions. Mitred longitudinal reinforcements in the column end zones and leaving 25 mm concrete cover causes the problem.
