NATURAL AND HUMAN-INDUCED SUBSIDENCE DUE TO GYPSUM DISSOLUTION: A CASE STUDY FROM INANDIK, CENTRAL ANATOLIA, TURKEY

Ergin Gökkaya^{1,C} and Esra Tunçel²

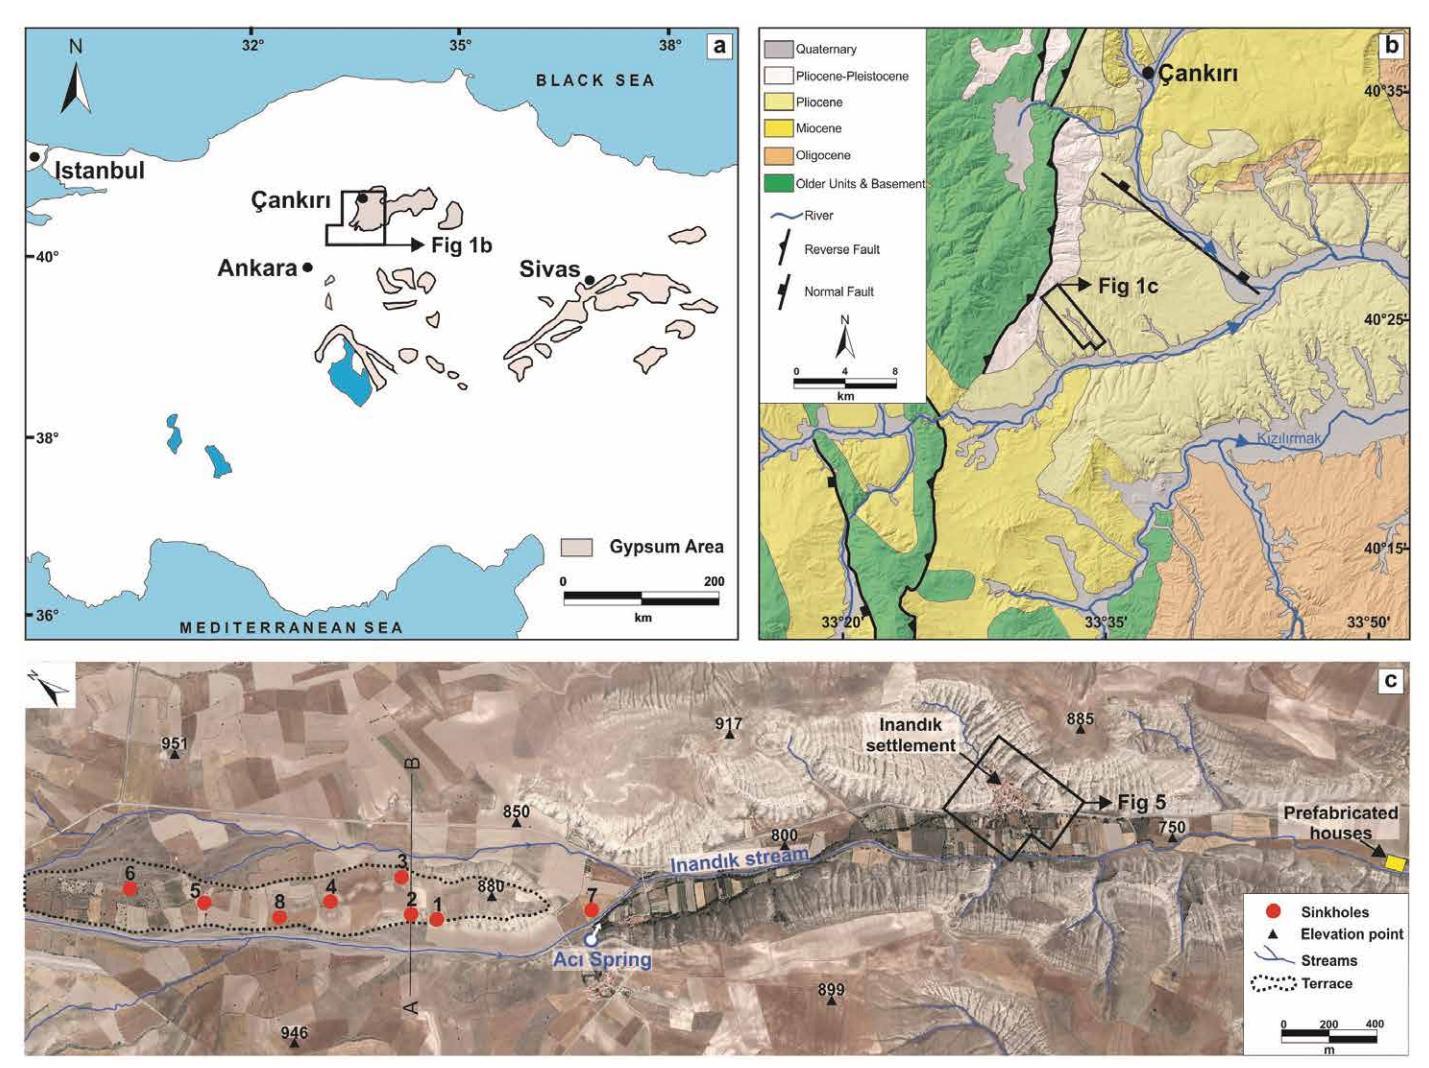
Figure 1. (a) Map showing location of study area. (b) Distribution of evaporite outcrops in study area and surroundings (modified from Karadenizli 2011). (c) Inandık village and vicinity.

The Kızılırmak drainage system developed in the basin at the beginning of the Quaternary, leading to closure of the basin. Karstification of gypsum and subsidence phenomena began when Pliocene evaporites were downcut by the Kızılırmak drainage system and overlain by loose alluvial deposits. The episodic downcutting of Inandık stream and its tributary in the study area generated a terrace 15 m above stream level and 25 m below adjacent ridges. The terrace is located northwest of Inandık village and its surface is overlain by alluvium 0 to 6 m thick (Fig. 1c).

To detect the sinkholes in the current study, aerial and satellite images were compared and eight collapse sinkholes were identified northwest of Inandik. These were numbered according to their date of formation (Fig. 1c, Table 1). Five of them existed before 1953. Except for sinkhole 7, that is the smallest, all the sinkholes are clustered on the river terrace. Local residents reported that sinkholes smaller than a meter in diameter, similar to sinkhole 7, had been found in the valley bottom, but were buried. These cannot be detected in aerial photographs because of their size and having been filled in soon after formation.

Inandık village is situated in a tributary valley on the eastern flank of Inandık stream with the SW part of the village within the main valley (Fig. 1c). There is no streamflow in the valley bottom since precipitation falling in the area surrounding the village in the rainy season is drained underground. The recharge to Inandık stream includes discharge from Inandık settlement which, we believe, has enhanced dissolution of the bedrock, as documented on paleo-subsidence structures (Fig. 3) which can be observed in many gypsum bedrock outcrops in the village, providing us with data about recent subsidence events. They also demonstrate that subsidence phenomena have been occurring over a long period. In support of this, information from inhabitants and local authorities indicate that the village has been affected by subsidence and sinkholes for generations. Although some damage occurred in the past, the frequency of subsidence events has in-
